Re: Jefferson local Development Corporation Brownfields Clean Grant - Montana Development Center Dormitory X Building #6

The Weston Solutions, Inc. (WESTON) Superfund Technical Assessment and Response Team (START) conducted a Phase II Environmental Site Assessment (ESA) for the South Campus Montana (MT) State Training School – Northern X Dormitory #6 located at Venture Way Boulder, MT (Site) (Figure 1). The ESA was conducted in accordance with Technical Direction Document (TDD) 0003/1808-05 and *ASTM, International (ASTM) E1903-11 – Standard Practice for Environmental Site Assessments: Phase II Environmental Site Assessment Process*. The purpose of a Phase II ESA is to acquire and evaluate information sufficient to achieve the objectives set forth in the Statement of Objectives (SOO) developed by the user(s) and the Phase II Assessor. The scope of a Phase II ESA is related to the activities agreed upon to meet the objectives of the investigation as defined in the SOO which are subject to ongoing evaluation and refinement as the assessment progresses. The SOO developed for this Site is presented in Section 1.2.

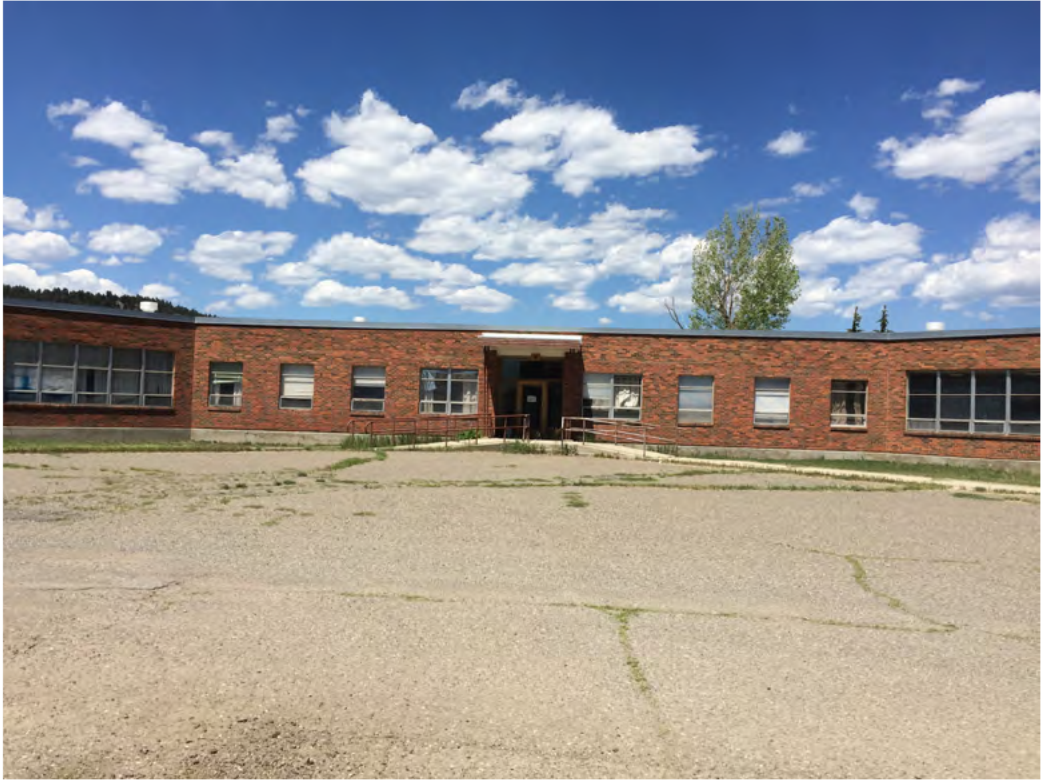
<b>Description:</b>  Front view of Building #6. All brick exterior and no LBP present.		
<b>Photo No.</b> <b>2</b>	<b>Date:</b> 08/02/2016

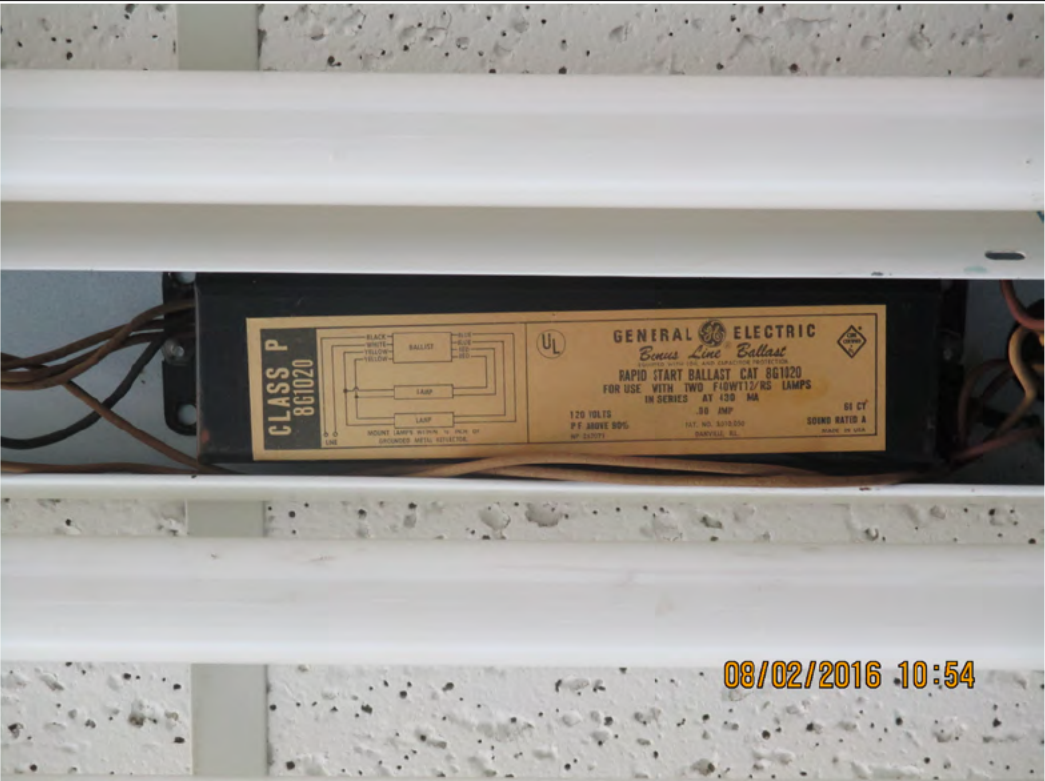
<b>Description:</b>  Potential PCB-containing ballast observed.

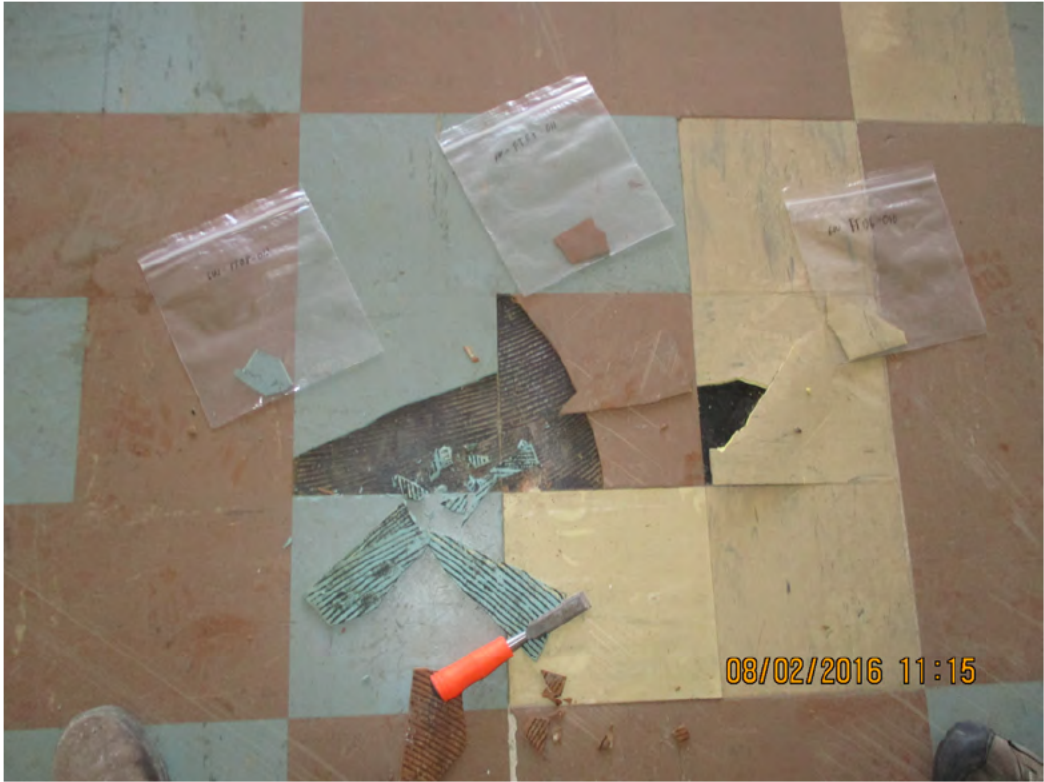
<b>Description:</b> Confirmed ACM samples 6W-FT07-011 and 6W-FT08-012.		
<b>Photo No.</b> <b>4</b>	<b>Date:</b> 08/02/2016

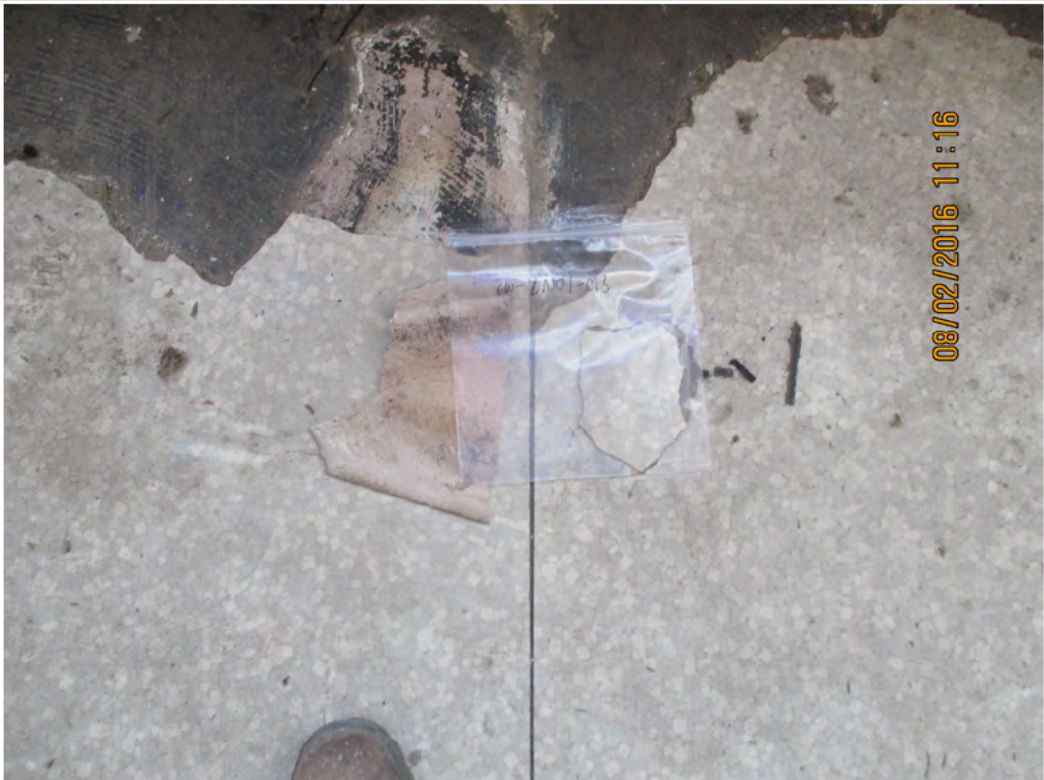
<b>Description:</b> Confirmed ACM sample 6W-LN01-013.

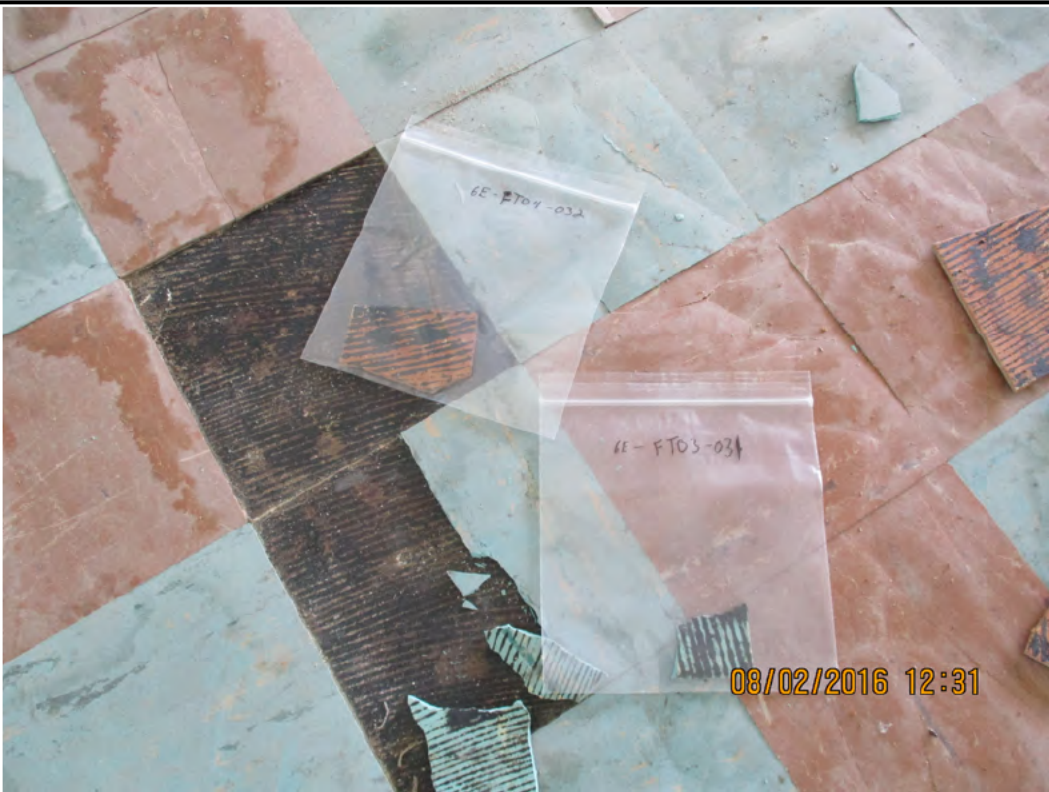
<b>Description:</b>  Confirmed ACM samples 6E-FT03-031 and 6E-FT04-032.		
<b>Photo No.</b> <b>8</b>	<b>Date:</b> 08/02/2016

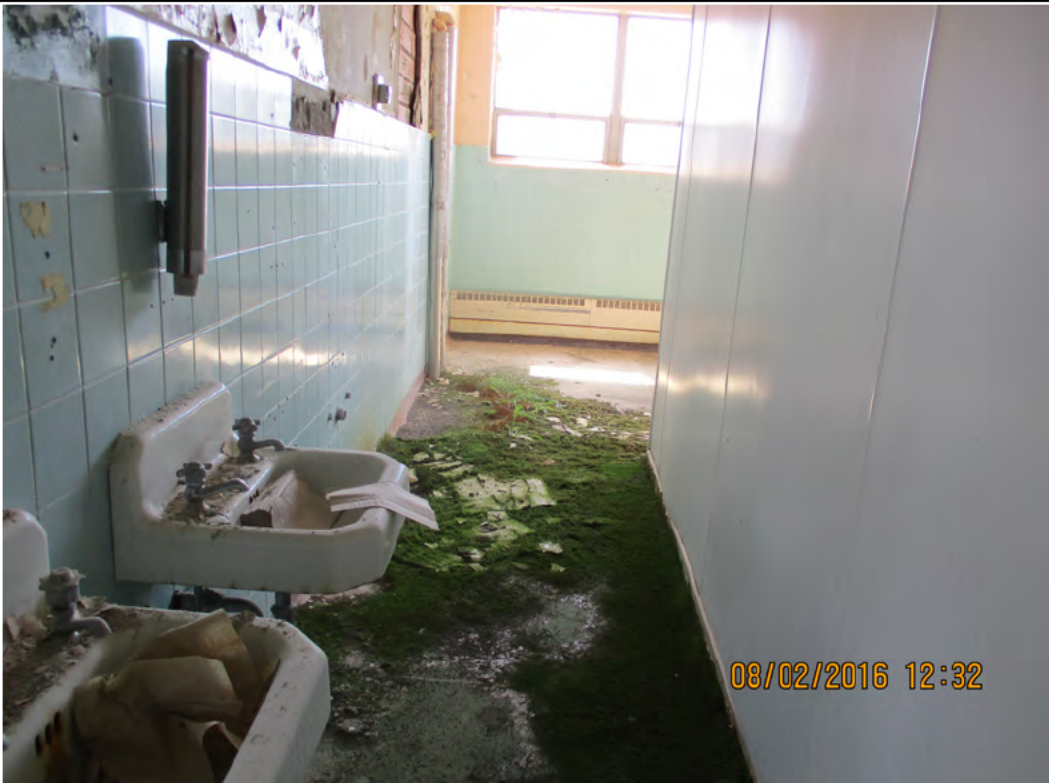
<b>Description:</b>  Some of the algae present in the north bathroom. Glazing on aqua tile is also leaded.

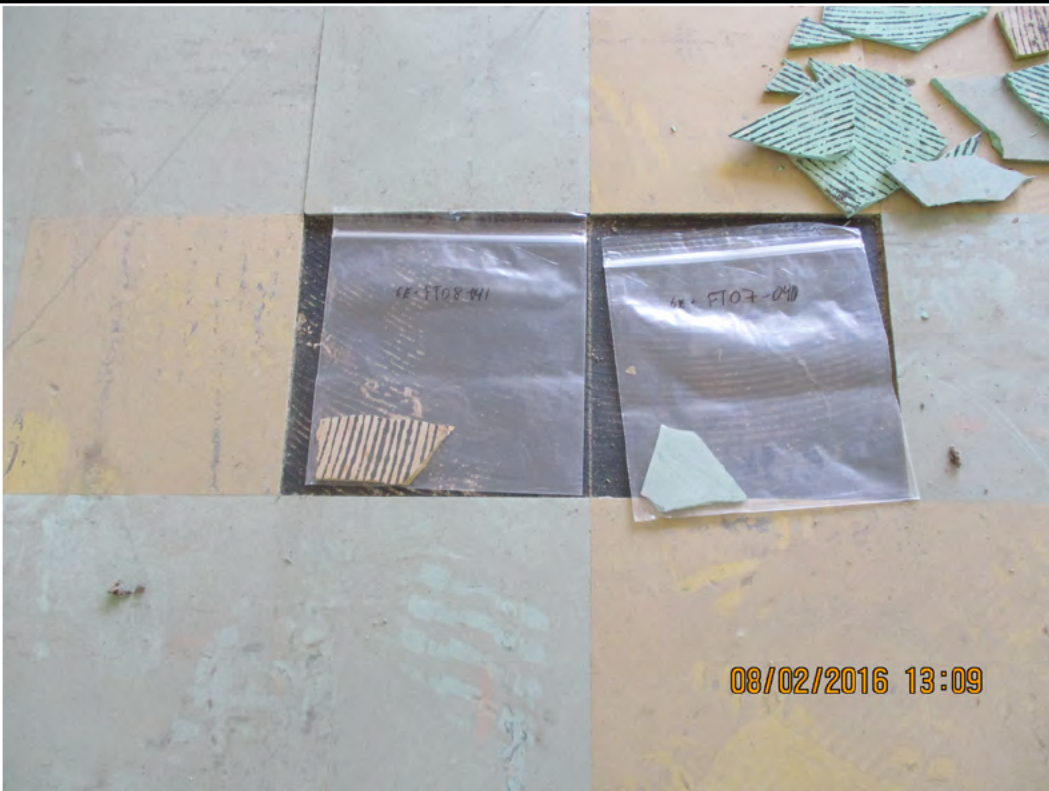
<b>Photo No.</b> <b>11</b>	<b>Date:</b> 08/02/2016	<b>Description:</b>  Confirmed ACM samples 6E-FT07-040 and 6E-FT08-041.

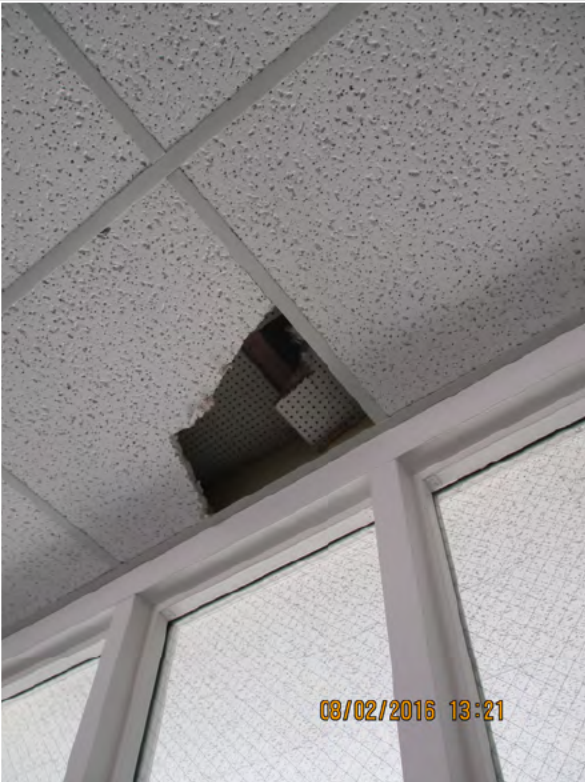
<b>Photo No.</b> <b>12</b>	<b>Date:</b> 08/02/2016	<b>Description:</b>  One of the ceiling tile scenarios. Upper tile is stapled to the joists and a suspended ceiling is below that.

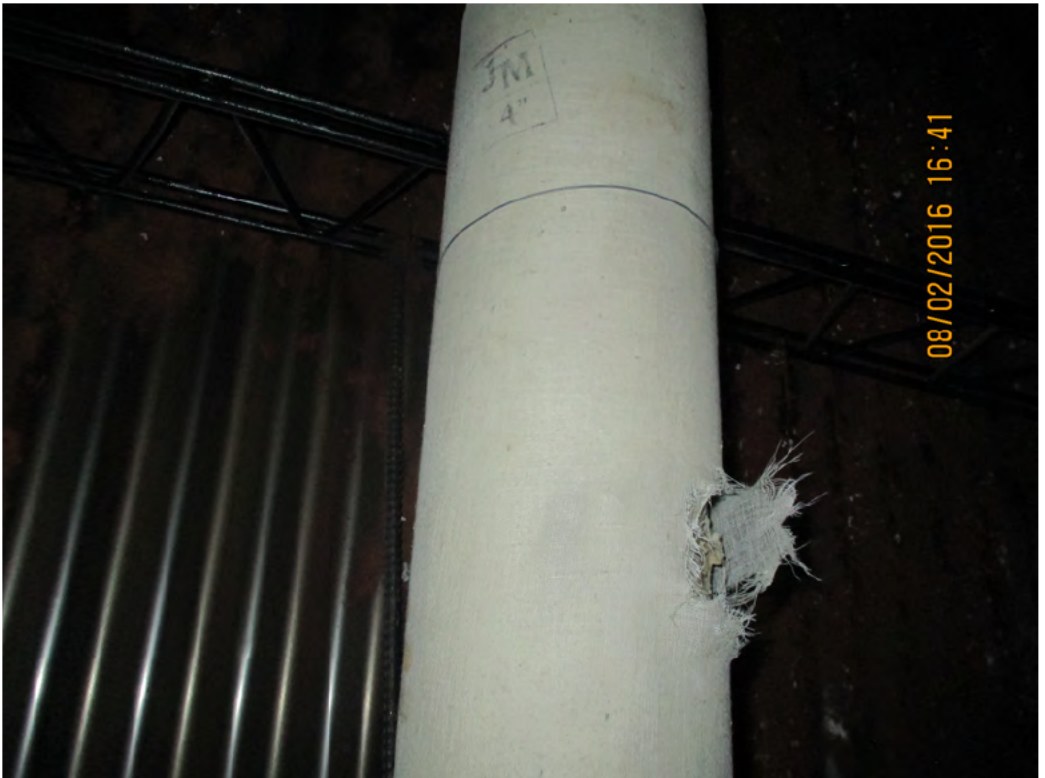
<b>Description:</b>  Johns-Manville Asbestocel 4" pipe wrap observed above the main hallway.

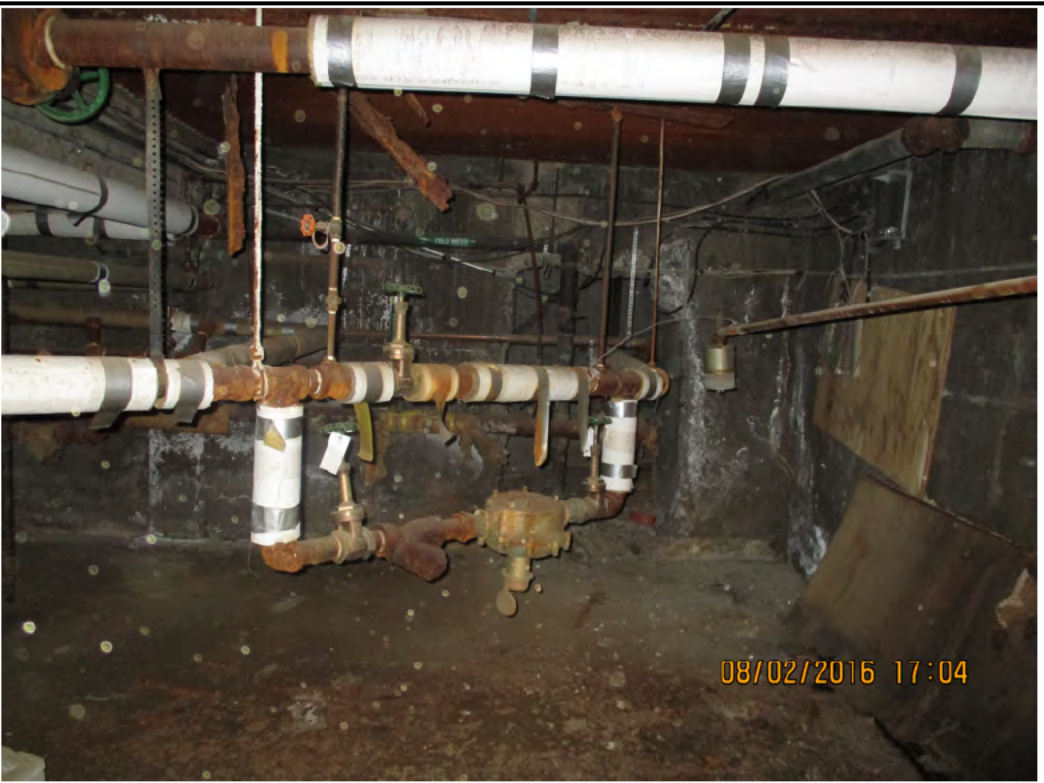
<p>08/02/2016 17:04</p>
Description:  Piping in the basement. Fiberglass insulation present on pipe runs and no fitting insulation. Opening straight ahead goes to the steam tunnel.		
Photo No. <b>24</b>	Date: 08/02/2016

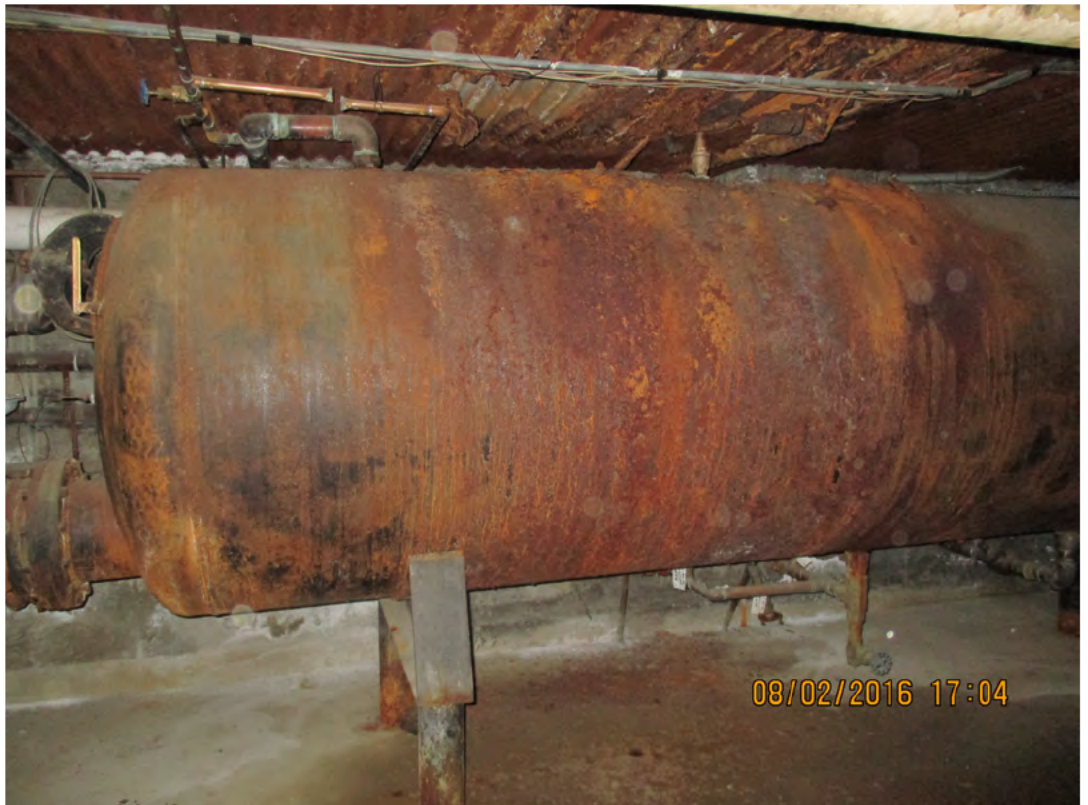
<p>08/02/2016 17:04</p>
Description:  Boiler with no jacket in the basement.

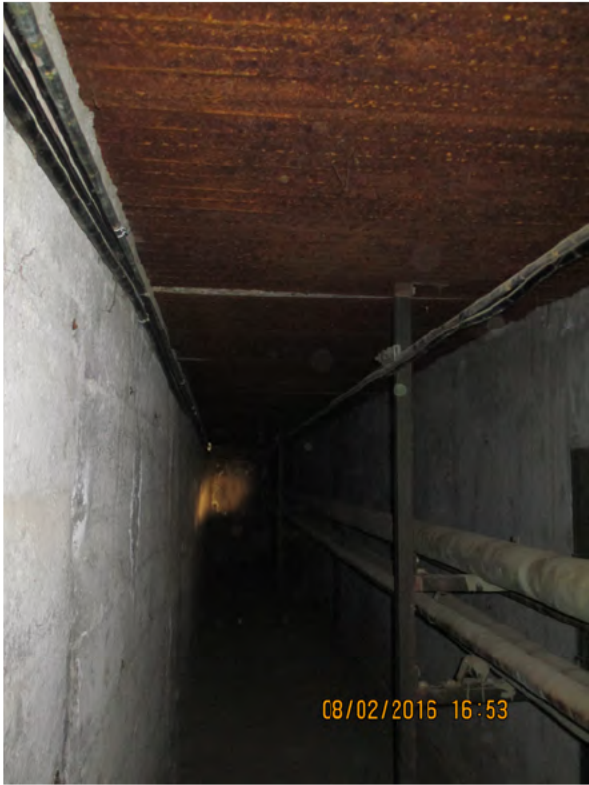
<b>Photo No.</b> <b>25</b>	<b>Date:</b> 08/02/2016	<b>Description:</b>  In the steam tunnel. Mostly fiberglass insulation on the runs but had some cementitious fittings in the vault below the manhole.

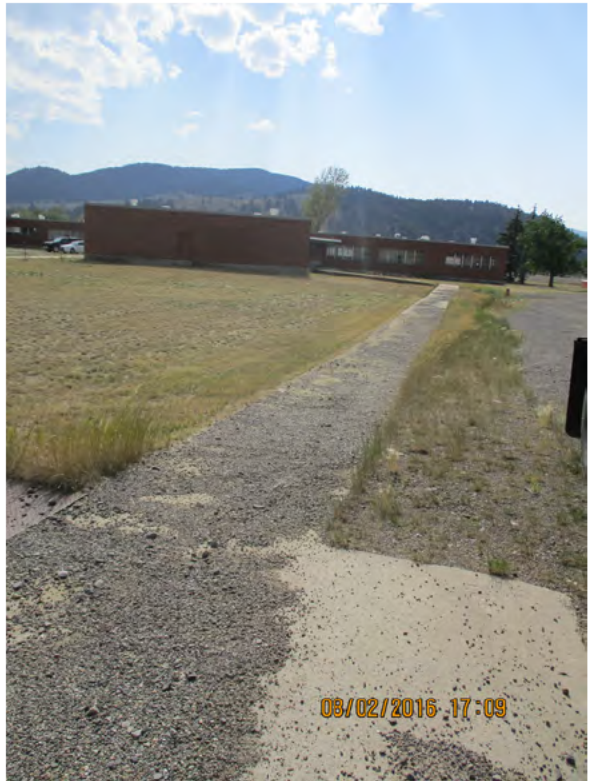
<b>Photo No.</b> <b>26</b>	<b>Date:</b> 08/02/2016	<b>Description:</b>  Standing on the manhole vault of the steam tunnel. Tunnel goes underneath the sidewalk from the building.
